Manhole Inspection Summary

Manhole # **S39GG_029MH**

Insp Date: **8/27/09 12:01 PM**

Location Address: **1201 PRESTON ST**

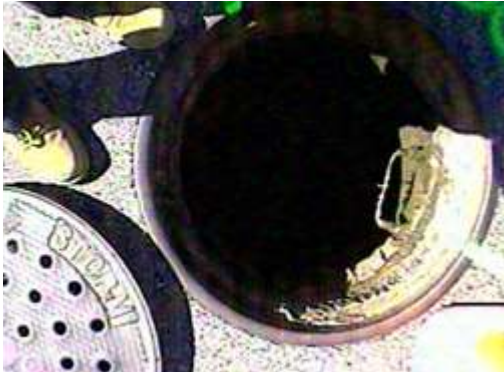
Defect 2

Steps Count: **1** Missing: **4** ☒ **Corroded**

CORRODED STEPS

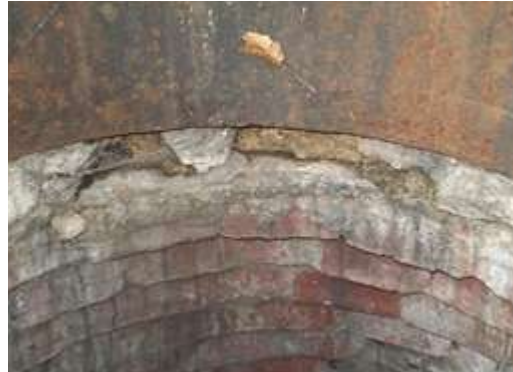
Defect 1

Condition: ☐ Sound ☒ **Cracked** ☐ Root Intrusion ☐ Loose Brick ☒ **Deteriorated**

CRACKED AND DETERIATED
CHIMNEY

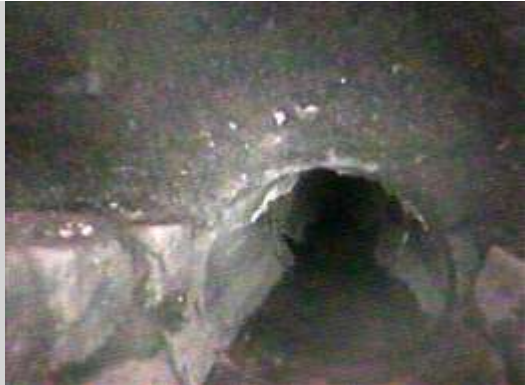
12 O'Clock Outflow

8 in. Circular Gravity Sewer
Pipe Out @ 12 O'Clock

Infiltration: **None** Pipe Seal Cond: **Sound**

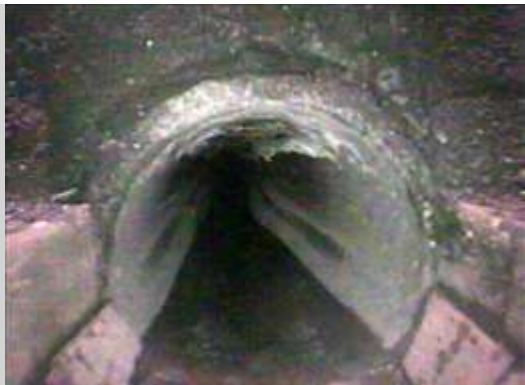
4 O'Clock Inflow

8 in. Circular Gravity Sewer
Pipe In @ 4 O'Clock

Infiltration: **None** Pipe Seal Cond: **Sound**
